# Global Peatland Restoration

## Manual

**Appendix: Live case studies**

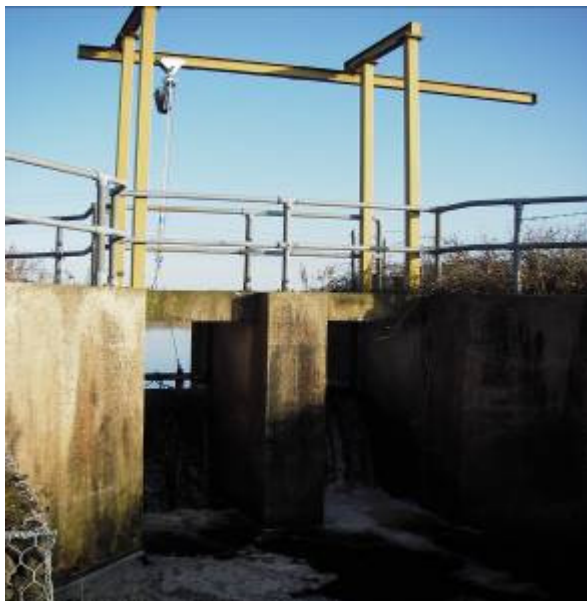
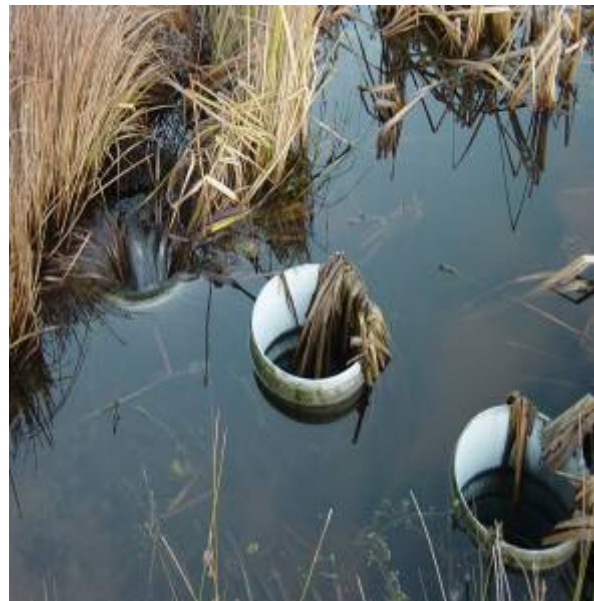
**Fig. 3:** Water control structures Left: concrete sluice at the point where the main ditch discharges into the river. Right: plastic overflow pipes controlling the water level behind a clay dam. (photos O. Bragg).

Between 1982 and 1984, a peat bund was constructed to reduce surface runoff into the main ditch discharging into the Afon (River) Erddreiniog and a concrete sluice was installed in 1993 where the river emerged from the mire. Other ditches were initially blocked with wooden boards and peat, and locally by clay bunds fitted with overflows made from plastic pipe.

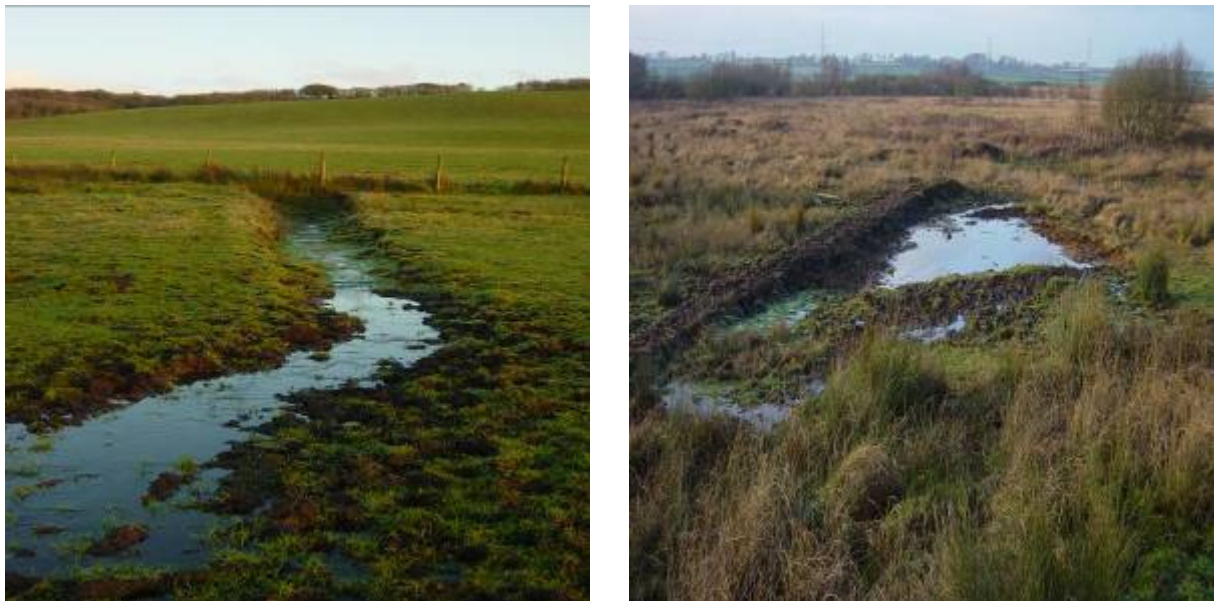
**Fig. 4:** Water management work at the eastern side of Cors Erddreioniog after 1998. Left: stream emerging from a buried agricultural field drain which has been severed at the site margin in order to allow base-rich water to flow into the peatland. Right: a new peat bund holding back water in a small pool on one of the north-south ditch lines. (photos O. Bragg).

In 1998, CCW purchased a strip of land on the eastern boundary containing several of the springs feeding calcareous water into the system and management work was moved to the eastern side of the site. Gradually, buried field drains carrying spring water into the drainage system are being severed at the site boundary so that the water discharges onto the fen surface, and north-south ditches are being infilled and bunded to compensate for shrinkage of the adjacent peat so that the spring water is able to flow across the surface onto the fen.

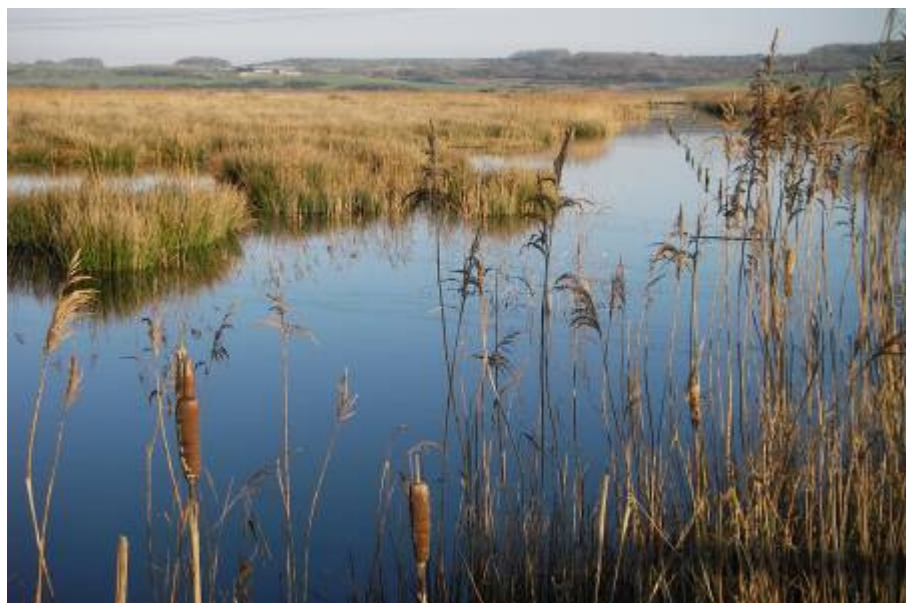
**Fig. 5:** Part of the re-wetted surface of Cors Erddreioniog (photo O. Bragg)

Since 1979, the depth of the water table has been measured regularly in lined ‘boreholes’ (Figure xx) by the CCW site warden. Analysis of the data collected up to December 1996 showed that the water table had generally risen relative to the mire surface over the preceding 17.5 years, suggesting some success in compensating quantitatively for diverted spring water by delaying the runoff of rainfall.

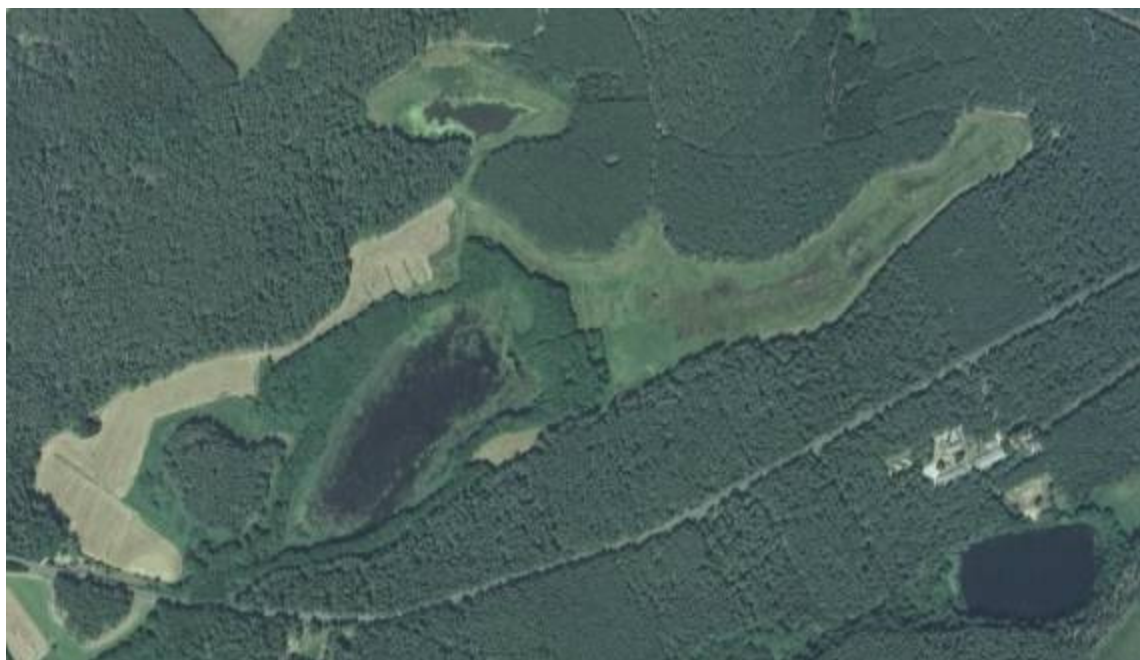
**Fig. 6:** The lake “Lehstsee” and its adjacent mires (focal area of the project: NE part)

The focus of the selected restoration project is on the restoration of a former percolation mire with up to 11 m of organic deposits including peat layers of about 5 m thickness on the east shore of the lake “Lehstsee” (see Fig. 6). The drainage of the peatland started during the 19<sup>th</sup> century and was intensified during the 1980s by numerous drainage ditches leading to a

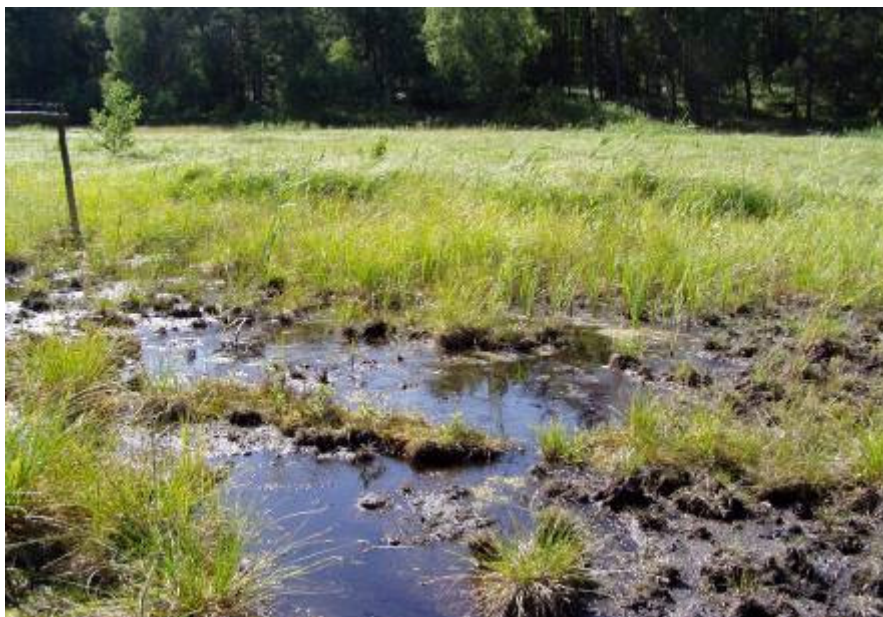
**Fig. 8:** Revegetation after shallow peat extraction (2000)

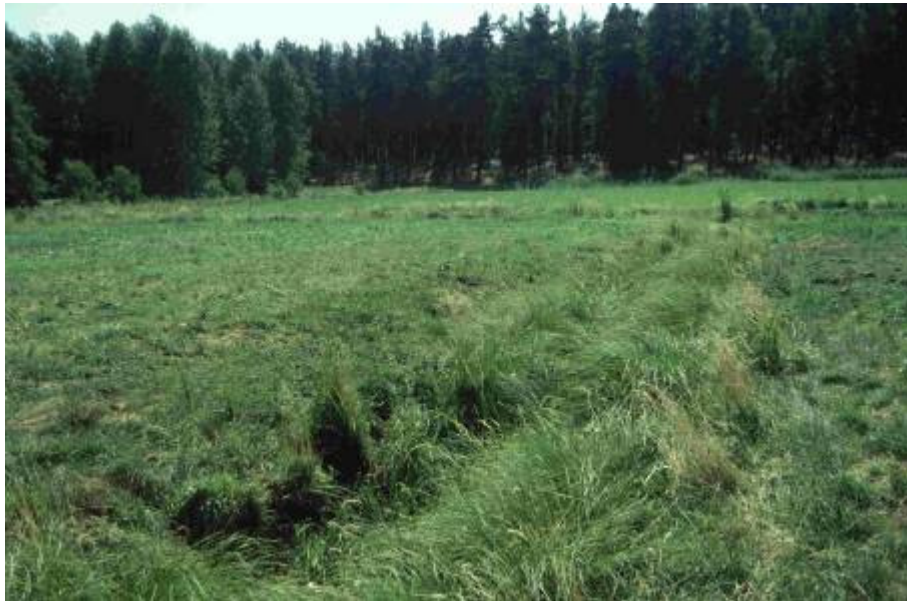
**Fig. 9:** Revegetation after shallow peat extraction (2002)

Until 2002 the lower parts were almost completely overgrown by *Carex paniculata* and *Carex acutiformis* and in small parts also by *Carex appropinquata* (s. Fig. 9).

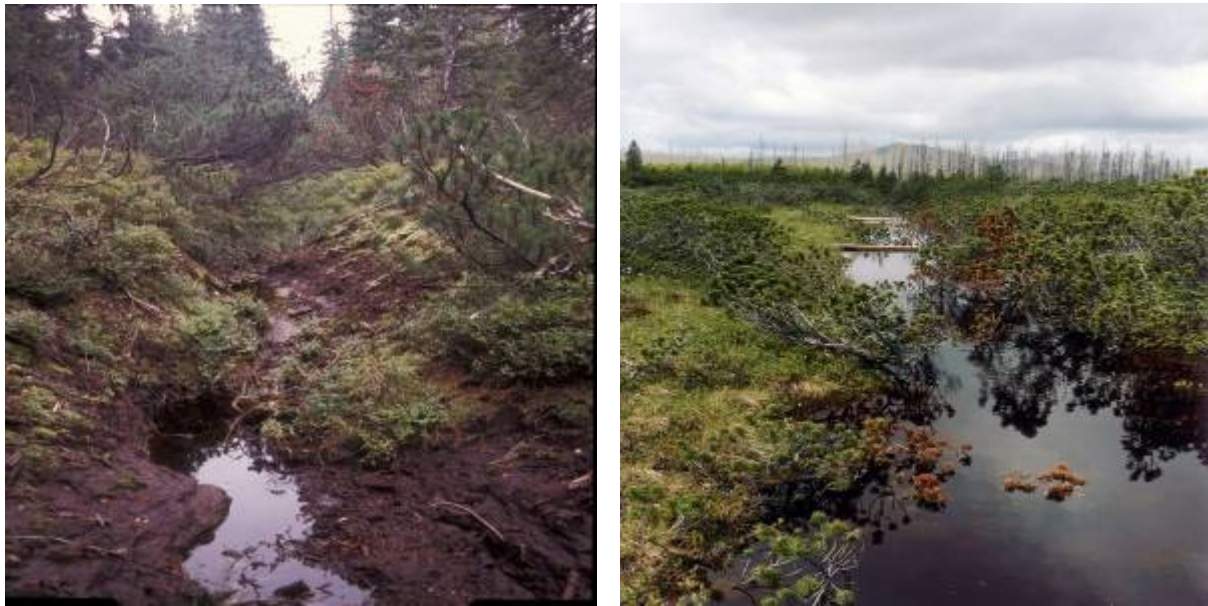
**Fig. 11:** Drainage ditches before and after restoration

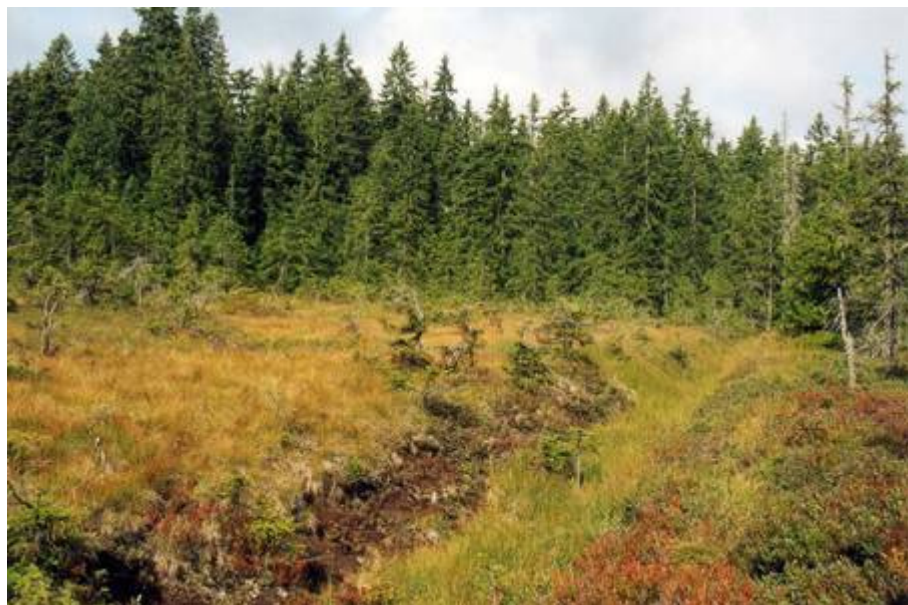
**Fig. 12:** Drainage ditch crossing bog-surface

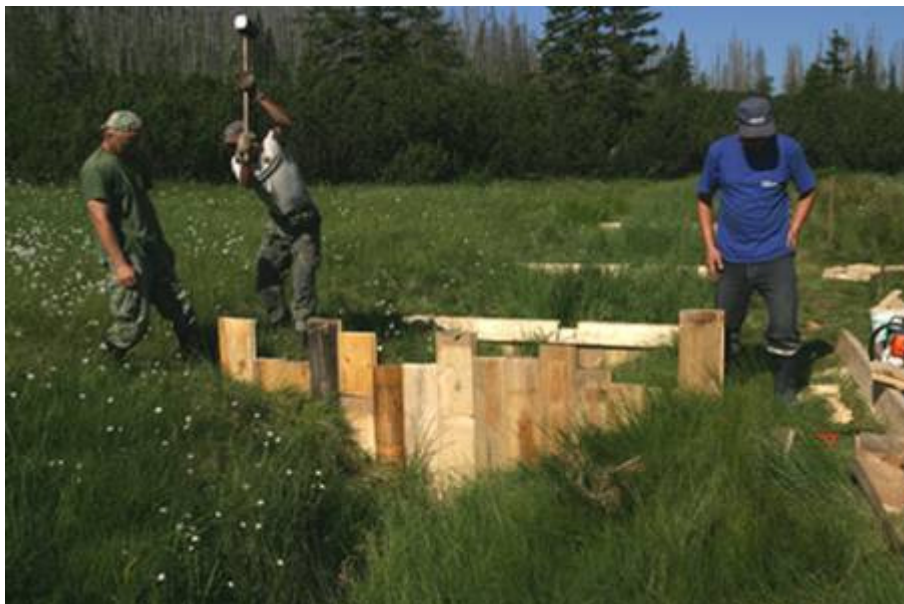
**Fig. 13:** Installation of wooden plank dams with overflow

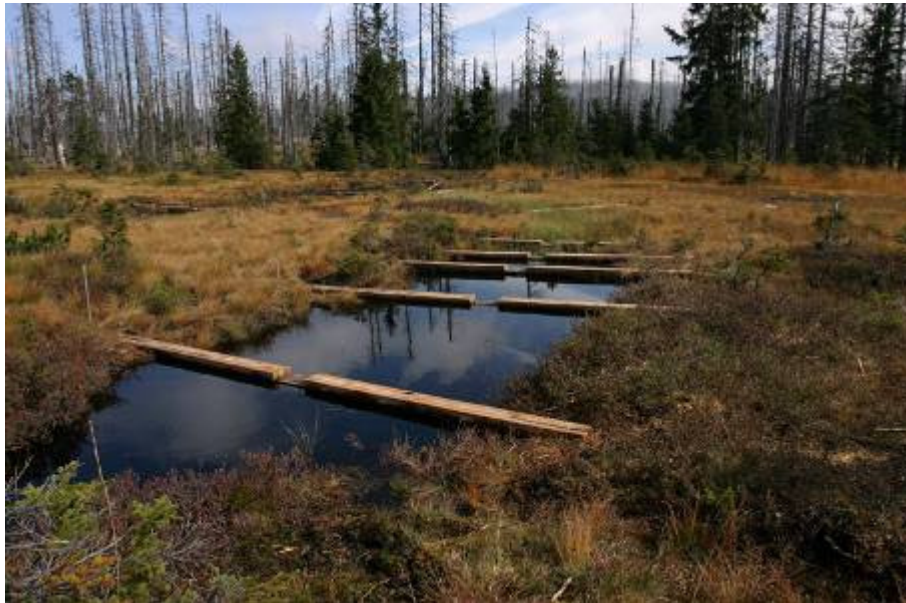
**Fig. 14:** Cascade of dams along a ditch

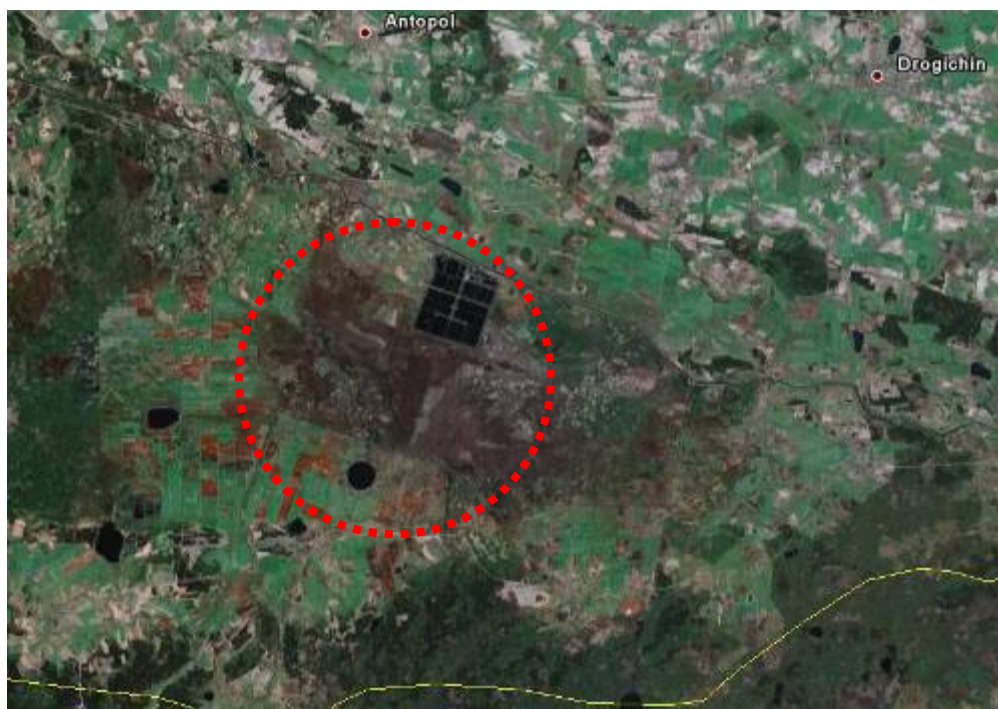
**Fig. 15:** Zvanets mire and it's surrounding

Their intensive use of water leads to serious water level changes (severe floods or rapid declines of the groundwater table) that are destructive to the mire and lead to unwanted vegetation successions, to extensive fires and to the destruction of bird nests by floodwater. The water source of spring floods is drained off by an extensive drainage systems within and surrounding the mire (Fig. 15 and Fig. 16).

From 2003 until 2005 fourteen water regulation facilities (overflow weirs (W 1-7), sluices (SL 1, 2, 5), sand-&-gravel blocks (S 1-4) – were built at Zvanets, see Fig. 15 and Fig. 17). In total about 80 000 USD were spent for implementing construction and monitoring activities.

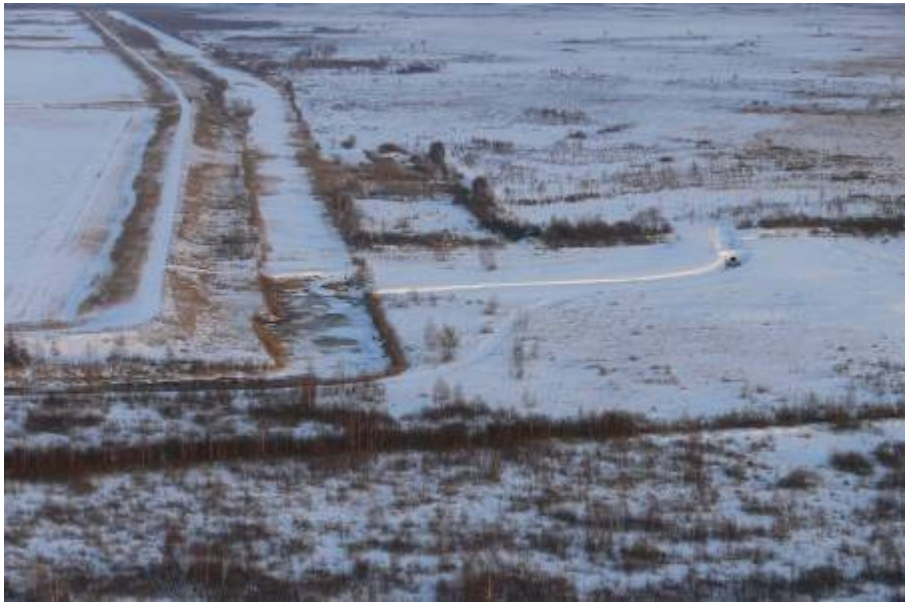
**Fig. 16:** Drainage network at the margins of Zvanets mire

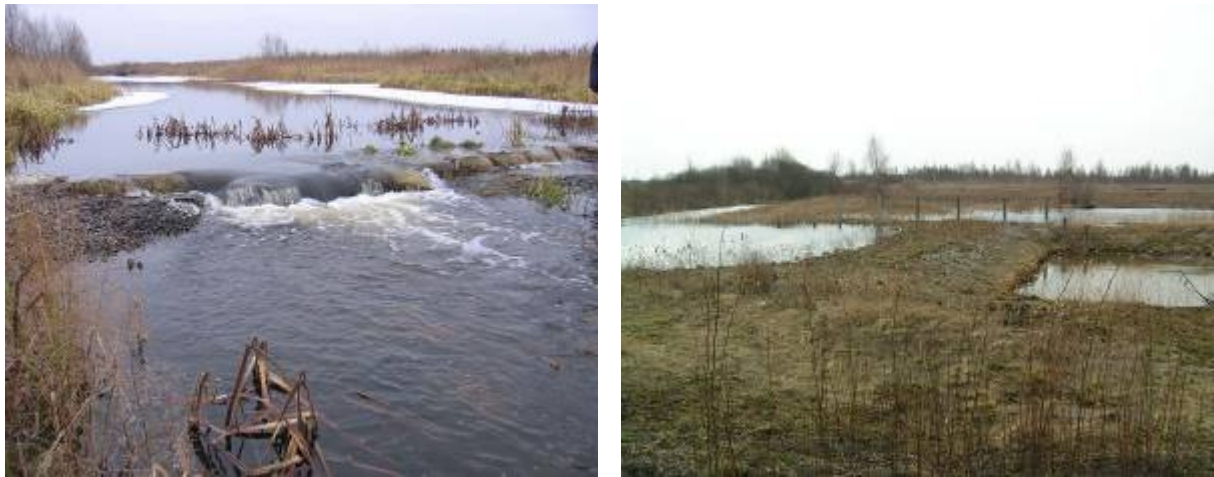
**Fig. 17:** Dam constructions at Zvanets mire

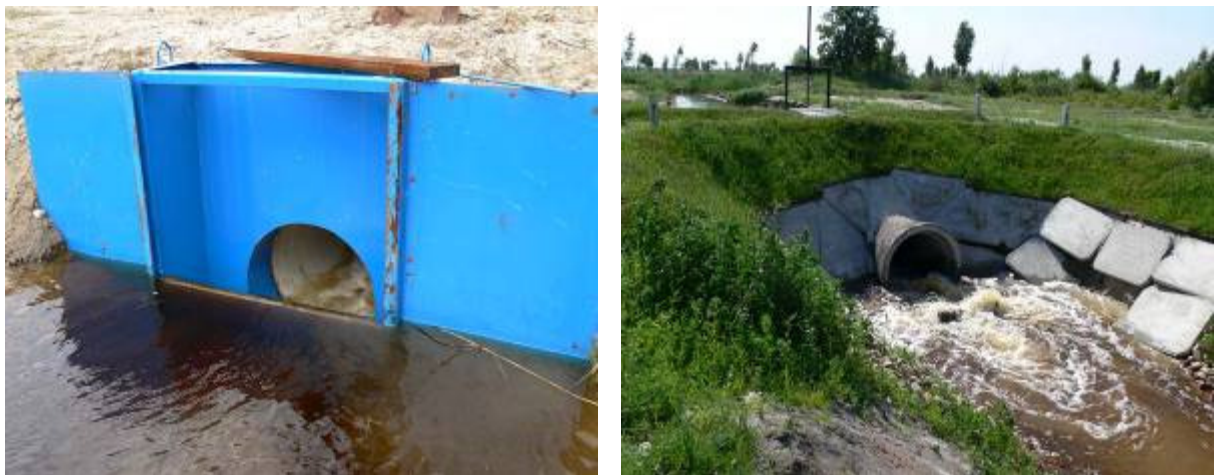
**Fig. 18:** Sluice constructions at Zvanets mire

Additionally, one adjustable sluice (SL-3) was built in 2005 by K. Marksa collective farm and another adjustable sluice (SL-4) was reconstructed by “Novoselki” fish farm as contributions of these enterprises towards the optimization of the hydrological regime of the mire. Most construction (W 1-7, SL 1, S 1-4) took place in the first year of the project.

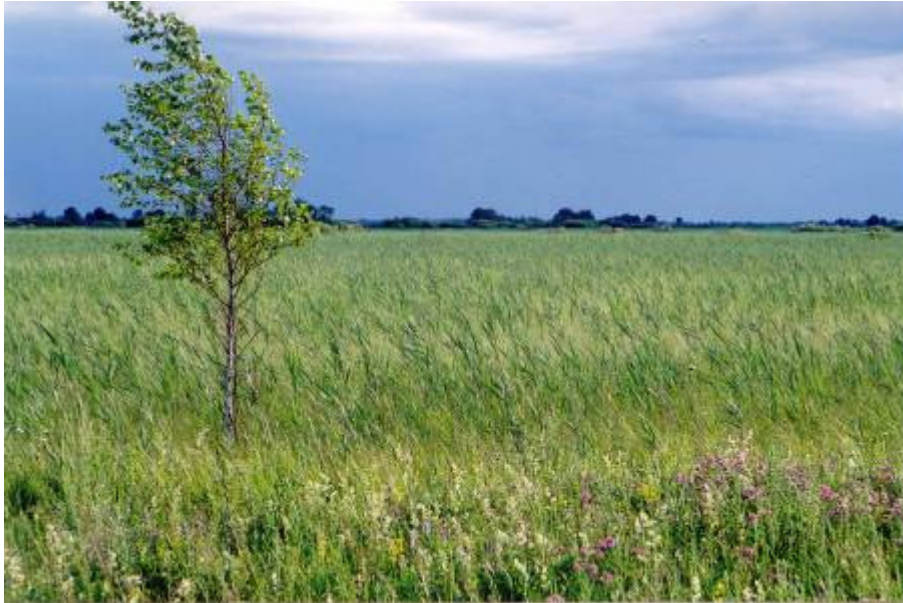
**Fig. 19:** Restored area at Zvanets mire

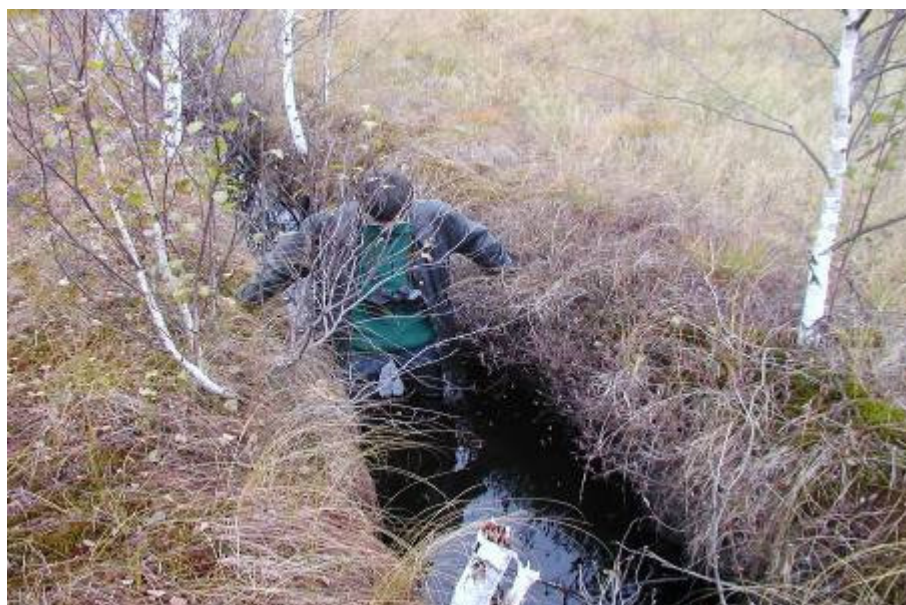
**Fig. 22:** One of the smaller drainage channels before dams were installed (photo S. Brooks)

The drainage channels on this plot were all deeper and wider than those seen in the UK, and were of two different sizes, the ditches marking the sides of the plot being connected by pipes to a larger canal at one end. The construction of dams was planned with and carried out under contract by the local peat factory “*Enterprise Kamska*”, providing employment for local people. It was anticipated that any metal or plastic materials used would be stolen, so each dam was made from two parallel wooden barriers with peat infill.

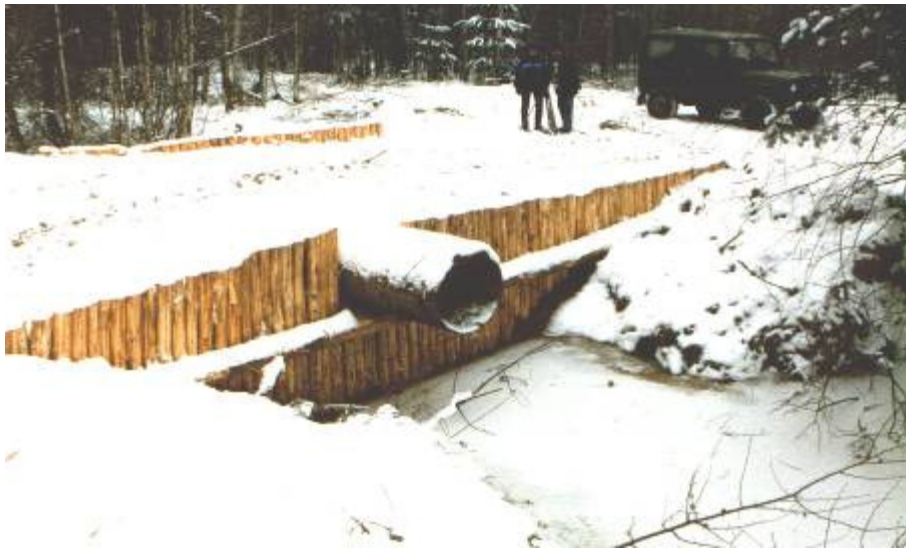
**Fig. 23:** A single dam, designed to double as a bridge (photo Ecological Centre Dront)

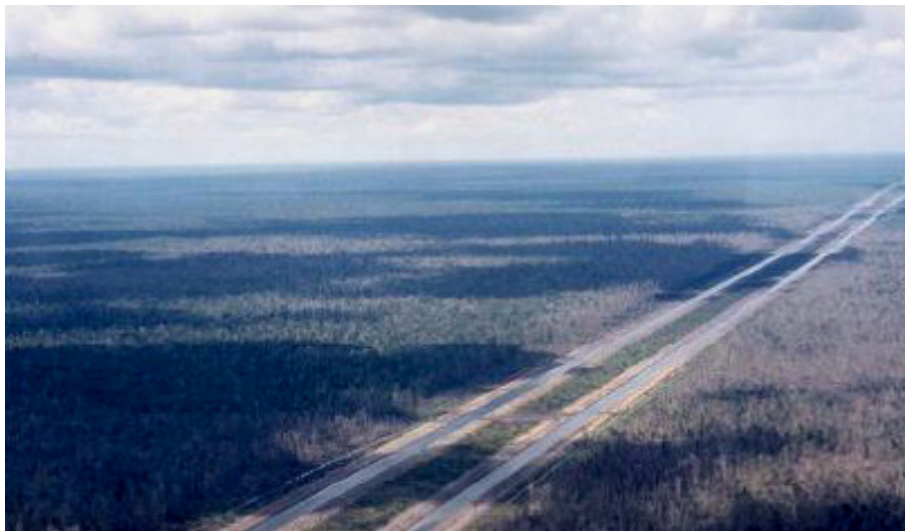
**Fig. 25:** Major drainage channels of the MRP in Central Kalimantan

Thousands of canals, with a total length of 4.470 km were built from 1995 until 1996 to prepare the area for agricultural use and for the establishment of 22.500 transmigrante households.

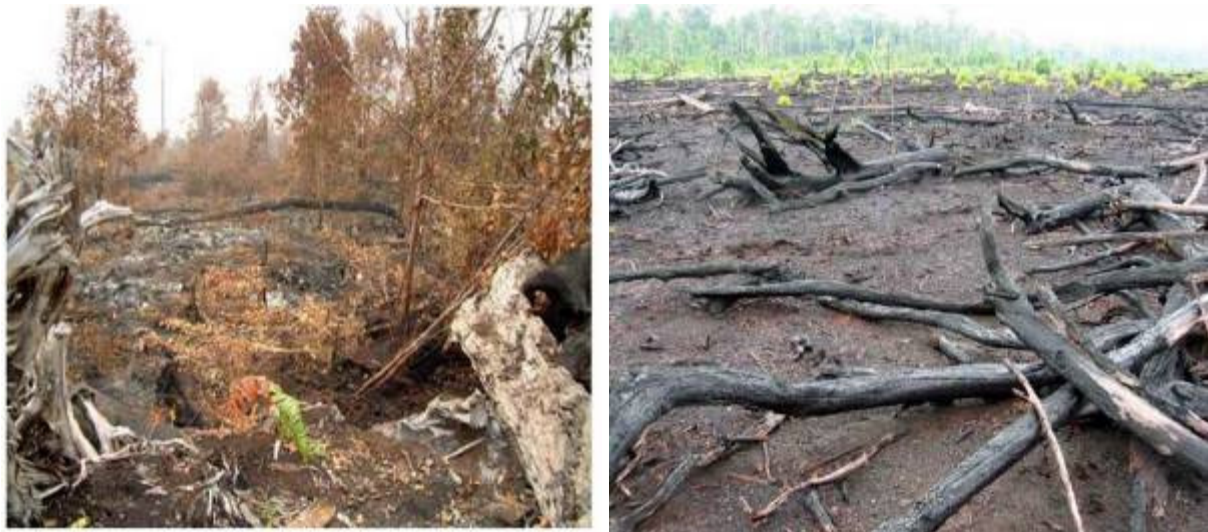
**Fig. 27:** Large areas are burning during dry seasons until the beginning of the rainy season

Regularly occurring fires within the area are the largest landscape disaster of recent times! If this situation continues the peatlands within the area, together all their benefits (see above) will disappear.

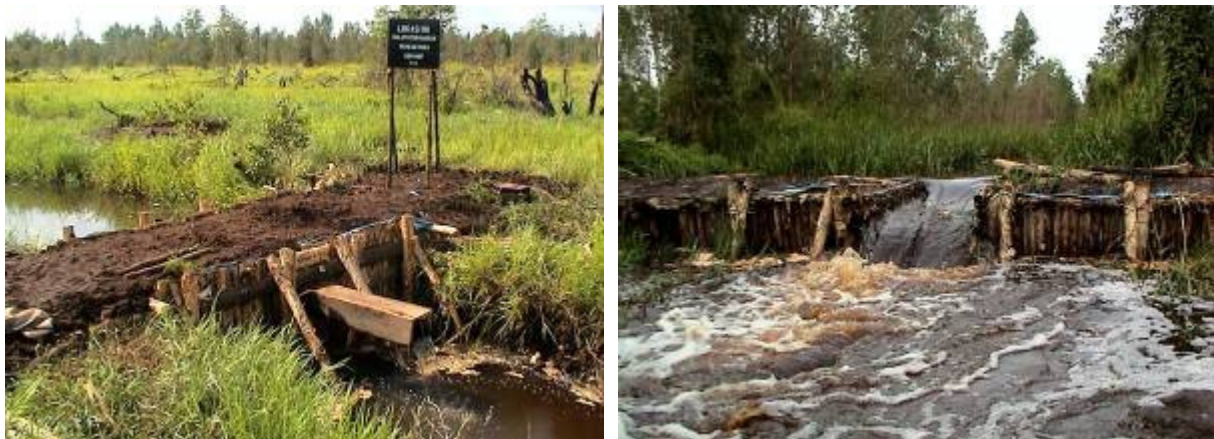
**Fig. 28:** Small dams made of wood, plastic and peat (blocking canals of 1 – 3 m width)

Small dams (1-2 m width and 0.75-1.5 m deep) were completed within 2-3 days, if 4-6 people were involved. All together (incl. preparation of material) a small dam costs about Rp 3-5 millions or 330-550 US \$.

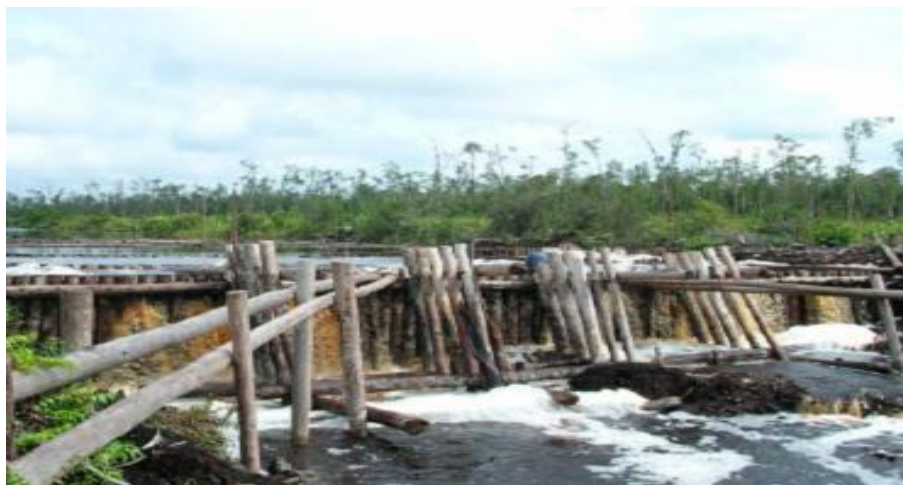
**Fig. 29:** Large wooden dam, filled with stones

Large dams (15-30 m wide and 1,5-2 m deep) required 70-90 days with the involvement of 10-16 people and about Rp 150-260 millions or 16,500-28,500 US \$ for completion. A detailed overview about the results of this project can be found in (Suryadiputra et al., 2005).

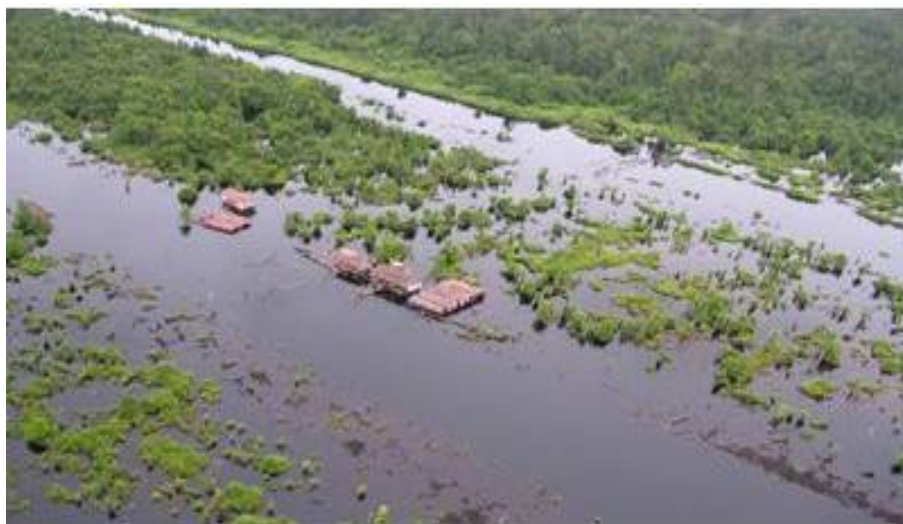
**Fig. 31:** Rewetted area of the former Mega Rice Project

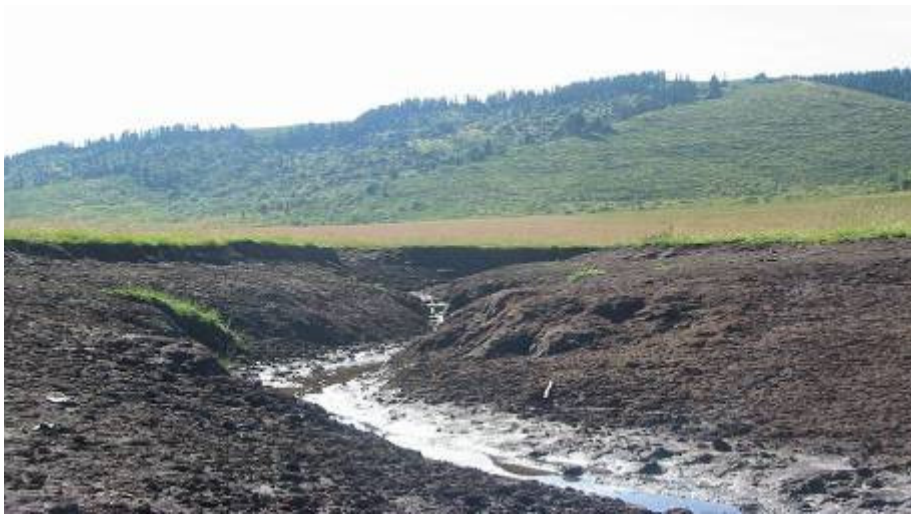
**Fig. 34:** Heavy erosion causes the development of erosion gullies

This leads, especially after vegetation damage through intensive grazing, to an increased risk of gully erosion in the peat and in the mineral soils, as well as to catastrophic flood occurrences further downstream.

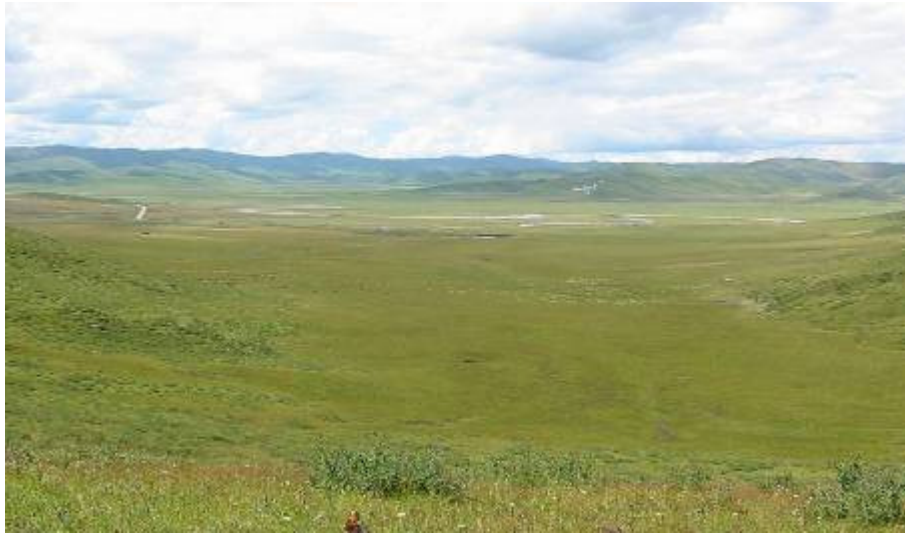
**Fig. 36:** View of Quqingmake peatland

A maximum peat depth of 7 m was determined in the central areas of the mire. The vegetation cover is dominated by sedges like *Carex* spp. and *Kobresia* spp.

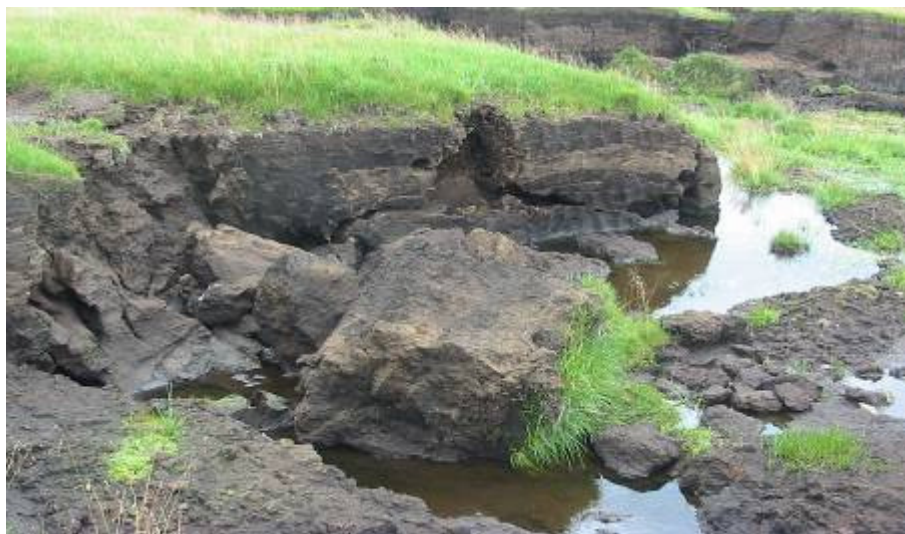
**Fig. 37:** Former peat cutting site (unplanned extraction led to heavy degradation)

The area of the peatland has been grazed by yak and sheep for hundreds of years. In its northern part the Chinese population of Hongyuan was cutting peat by hand for private use (heating and cooking) and as fuel in a brick factory. The cutting of peat, which was not carried out according to any plan, has resulted in serious environmental degradation. The unplanned peat extraction was stopped by the local authorities in 1991 but had to be allowed to meet the fuel demands of the citizens of Hongyuan Town.

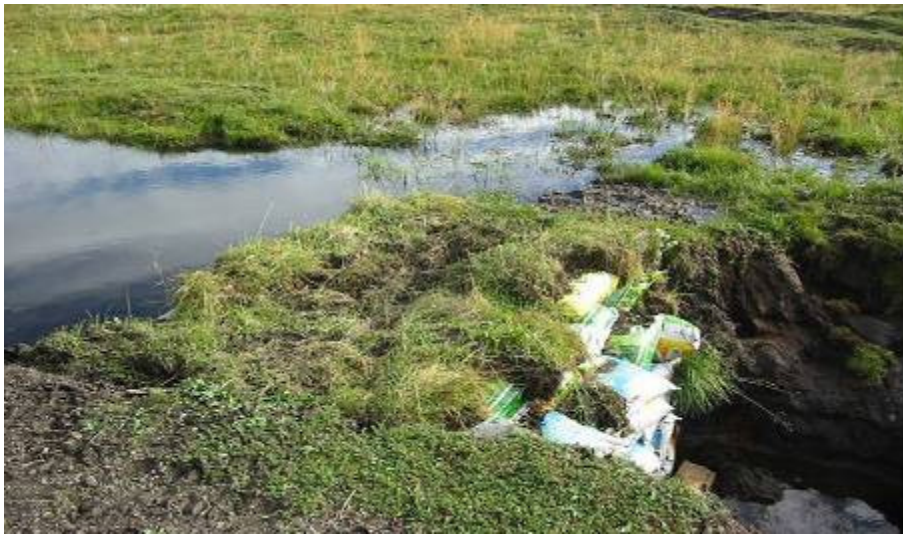
**Fig. 38:** Dam made of plastic bags, filled with peat

*No device for the controlled overflow of water has been established. Surplus water is running around the sides of the dams and causes erosion that leads to the dam failure.*

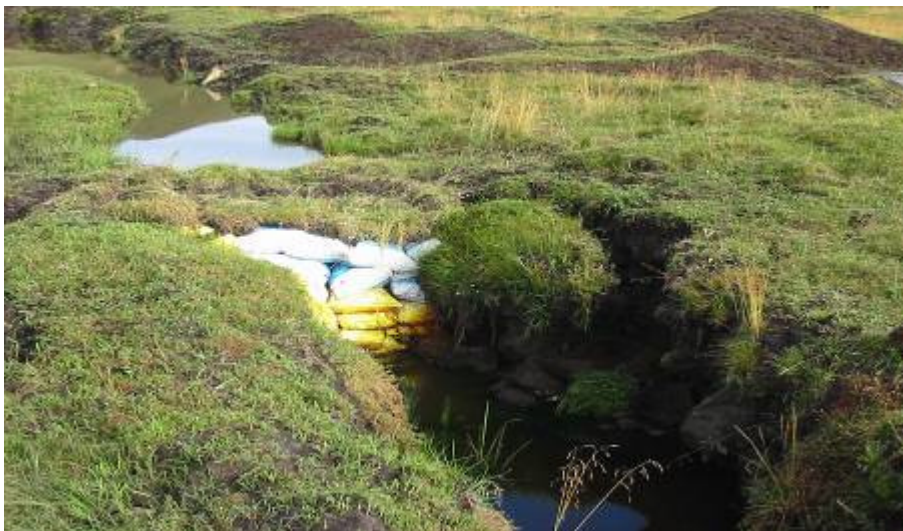
**Fig. 39:** Dam is backing up water

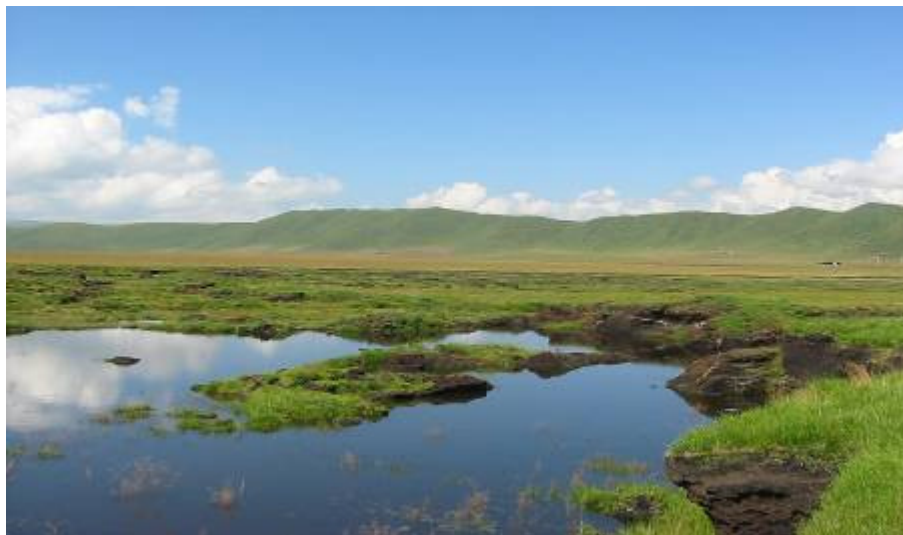
**Fig. 40:** Rewetted peat cuttings (after surface levelling)

*Positive effects of rewetting and revegetation were achieved only in small parts of the former peat cutting site yet. More funding would be necessary to construct an adequate number of dams to reach a rewetting of bigger parts and to spread the water flow across the whole area. The long term success of the project will depend on the grazing regime of the area. Therefore the adequate grazing capacity of the site has to be identified and controlled.*

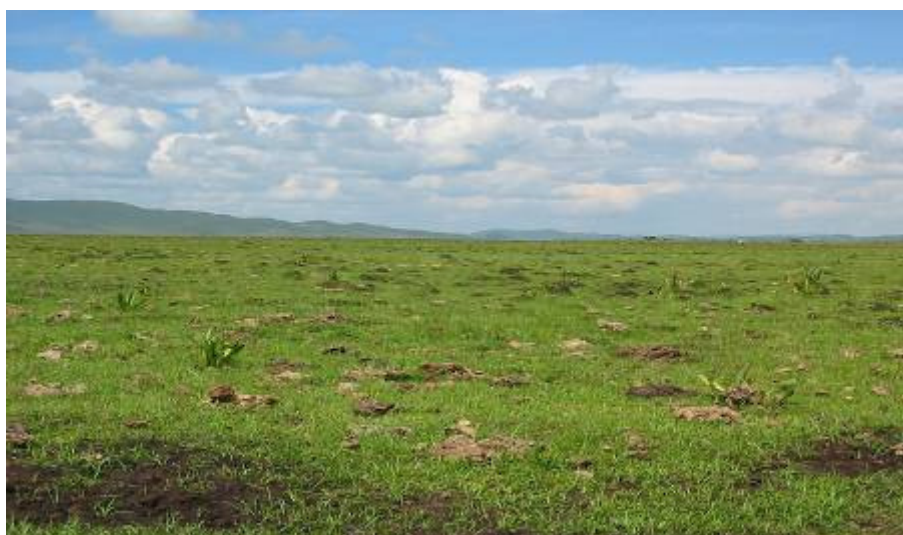
**Fig. 43:** Heavy over grazing leads to the increase of non fodder plants

Several years ago these ditches were abandoned but continued to drain water off the site. Too many animals turned great parts of the mire into “black deserts” of bare peat, which is prone to heavy erosion. The species composition changed – non fodder species were increasing. Local Tibetan herdsmen have get drinking water from several kilometres away because the previously water soaked wet mire turned into a dry, degraded pasture!

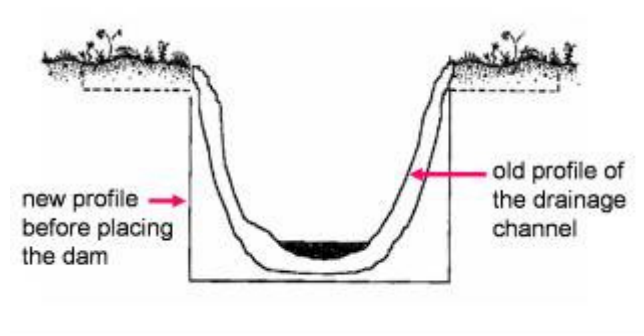
**Fig. 44:** Preparation of the ditch (changed after Brooks and Stoneman, 1997a)

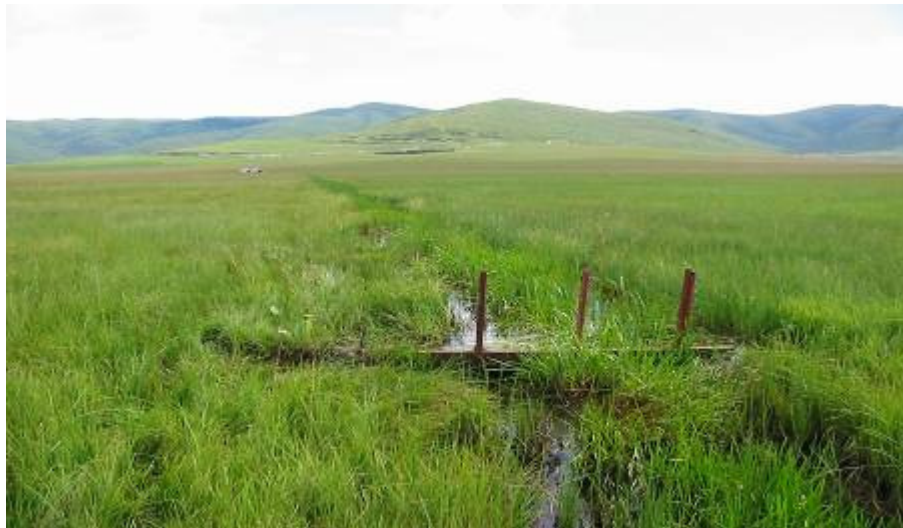
**Fig. 45:** Wooden plank dam

Both the constructions of dams made of plastic bags and of wooden planks did show positive results in backing up water in drainage ditches. Because plank dams are more stable (better to anchor within the sides of the ditch) they seem to be more suitable for those conditions. But it has to be considered that the construction of solid plank dams is very labour-intensive and that every kind of wood is highly demanded as construction material and as fuel and therefore often dismantled by local people. Long term monitoring will be necessary to investigate the durability of untreated wood, especially at the air/water interface.

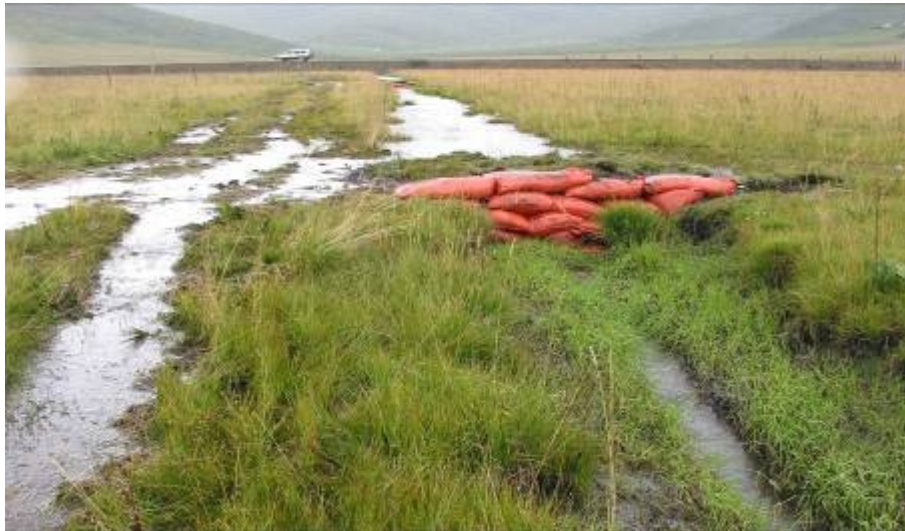
**Fig. 46:** Successful rewetting by a small dam made of plastic bags, filled with sand

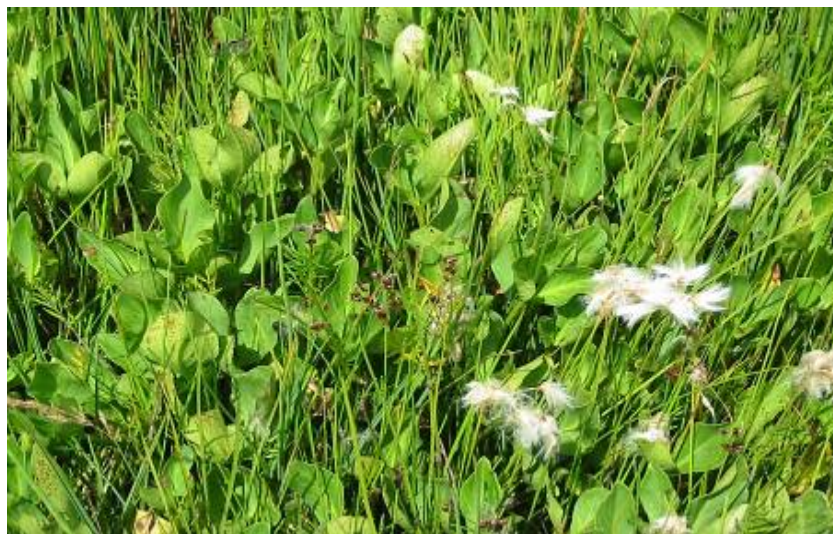
**Fig. 47:** Positive results of rewetting, large swampy areas with typical vegetation

The success of rewetting on the site is clearly indicated by the spreading of hygrophyte species. Already in summer 2005 large areas were covered by typical wetland species like *Equisetum ssp.*, *Eriophorum ssp.* and *Menyanthes ssp.* (see Fig. 46). The latter are typical peat forming species.

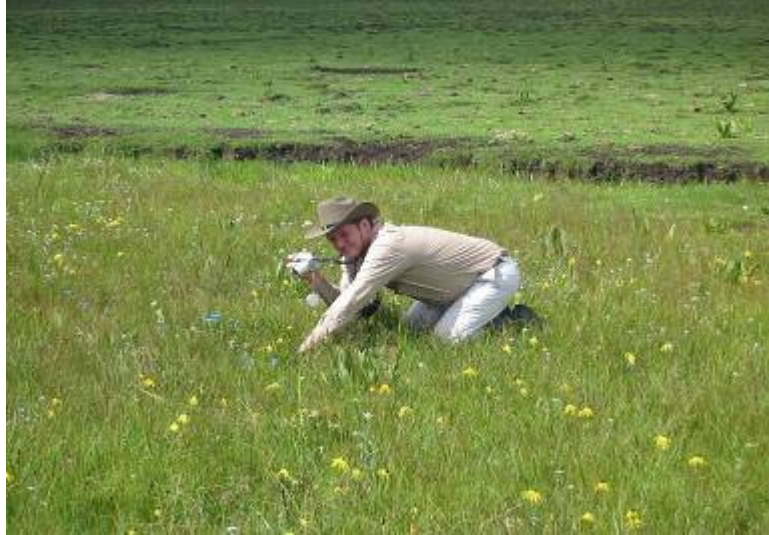
**Fig. 48:** Different of grazing regimes (front: reduced grazing, back: over-grazing)

There are also positive effects of reduced grazing intensities within the restoration site. Figure 64 clearly shows the difference of strongly grazed areas and areas, where the grazing is reduced.
